**AGENDA FOR  
RECLAMATION DISTRICT NO. 404  
BOARD OF TRUSTEES REGULAR MEETING  
10:00 A.M. OCTOBER 20, 2026**

## II. CITY OF STOCKTON PUMP DISCHARGE PIPE REPLACEMENT – SJ RIVER & HIGHWAY 4

# San Joaquin River

## Hydrographic and Side Scan Survey Report

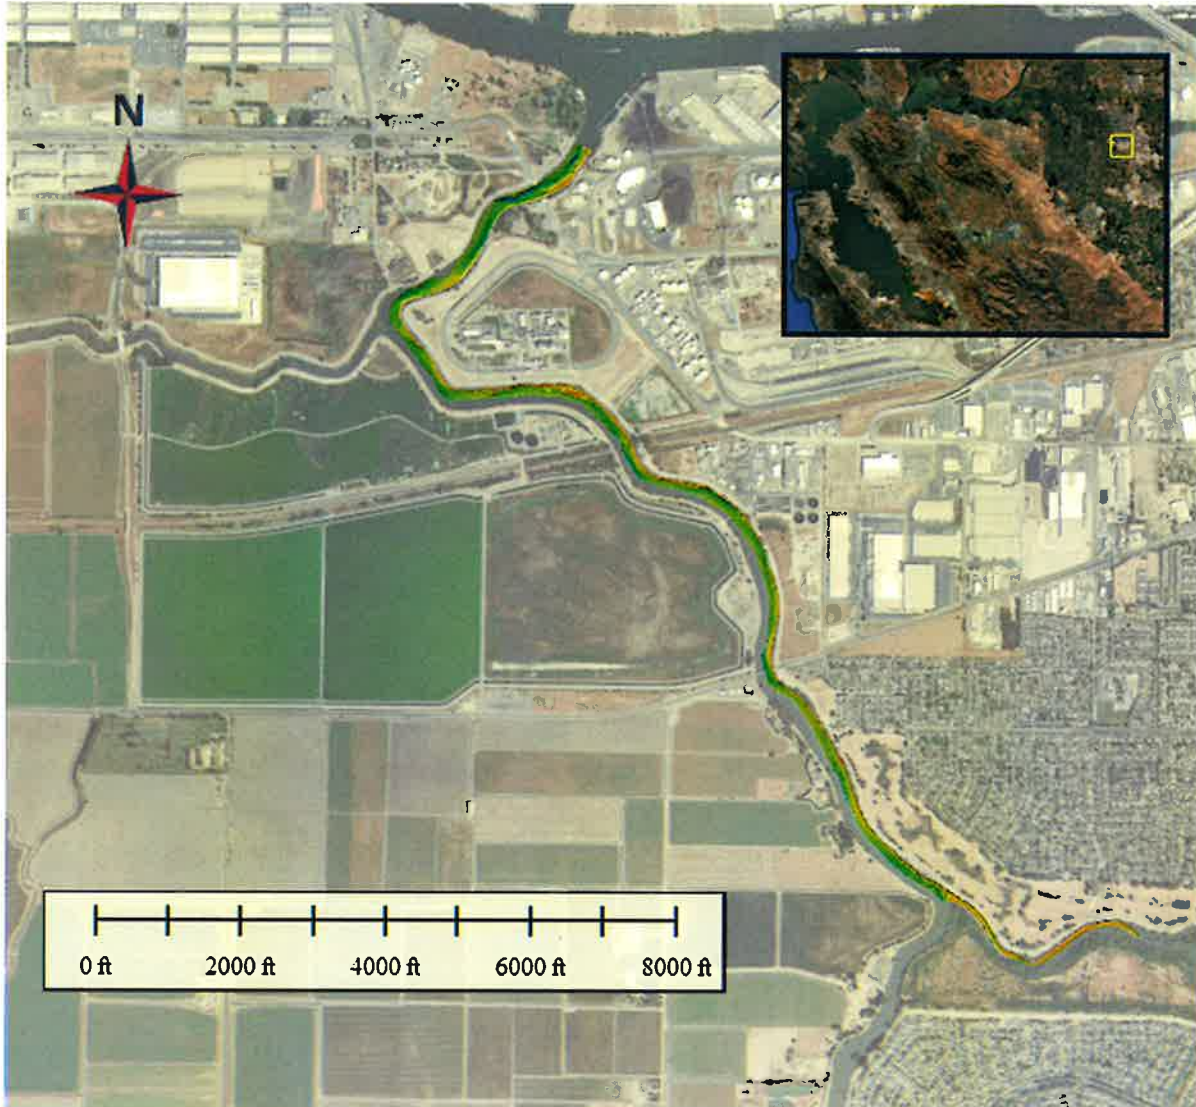
Figure 2-1 – San Joaquin River Overview

From July 15-17, 2026, Woolpert completed hydrographic and side scan survey operations along the San Joaquin River in Stockton, California. Survey activities included multibeam bathymetry and side-scan sonar.

The project location and bathymetric surface are shown in Figure 2-1.

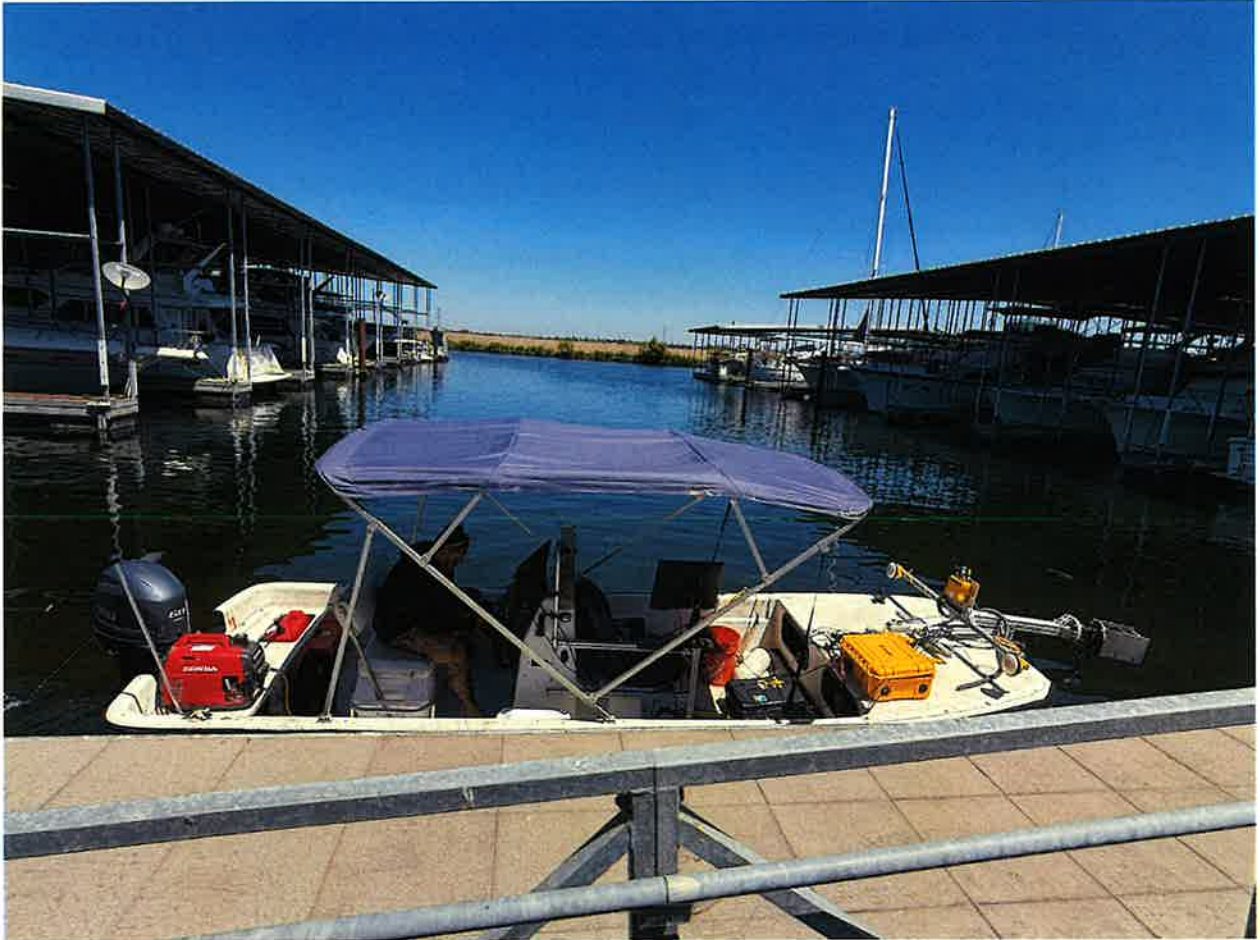
**Figure 4-1. S/V Surveza**

From Woolpert's extensive fleet of vessels, *R/V Surveza* was chosen for all survey operations. *R/V Surveza* is a Carolina Skiff, hydrographic survey vessel of 18 feet. It is a proven vessel for high-quality data collection. *S/V Surveza* is shown below in Figure 4-1.

A positioning and motion reference system was installed on *S/V Surveza* to support hydrographic data acquisition. The system uses a long GNSS antenna baseline to support accurate heading and reliable positioning during survey operations. Inter-sensor offsets were measured and applied within the acquisition system to accurately relate the sonar, motion sensor, and GNSS antenna positions.

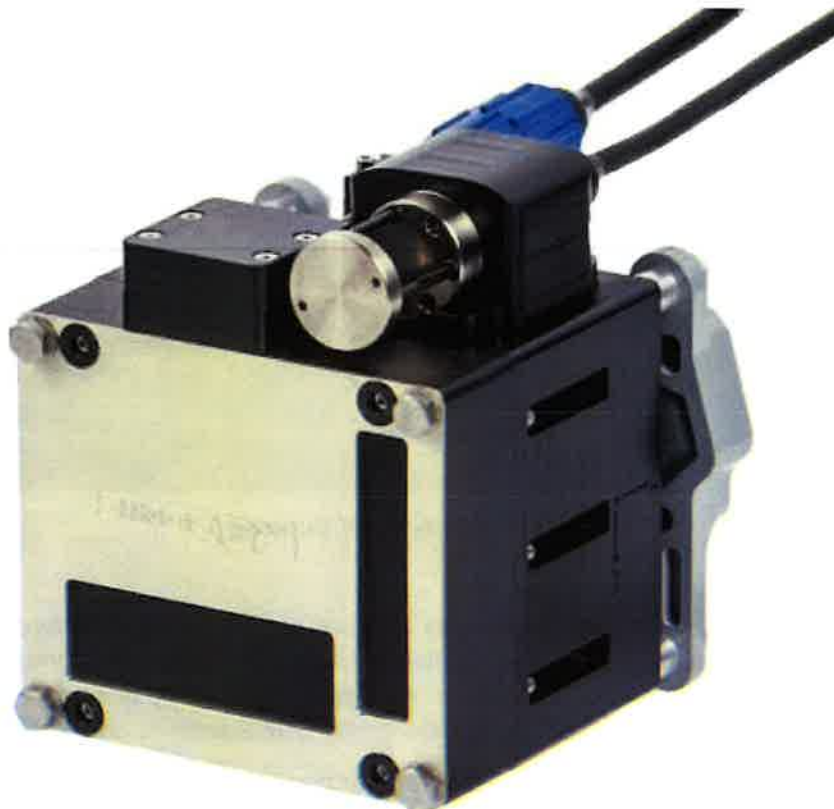
Figure 4-2 – R2Sonic 2020 multibeam sonar

- Selectable operating frequency range: approximately 200–400 kHz
- Beamwidth: approximately 2° x 2° at 400 kHz
- Swath coverage: up to approximately 160°, depending on survey settings and site conditions
- Soundings per ping: up to 256
- Depth range: dependent on frequency, environmental conditions, and survey settings

The MBES system included a sound velocity sensor at the sonar head to provide real-time sound speed measurements at the transducer. These measurements were used for beam forming and applied during multibeam data processing. Additional water column sound velocity profiles were collected as needed for refraction correction.

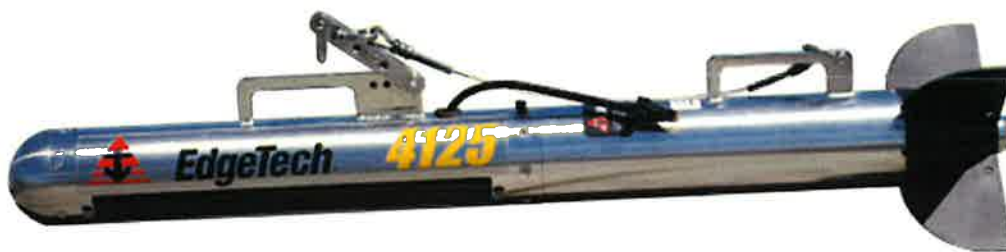
**Figure 4-3 – EdgeTech 4125 Side-Scan Sonar**

An EdgeTech 4125 side-scan sonar system was used to collect acoustic imagery of the survey area. The side-scan sonar data were used to review bottom conditions and identify visible contacts, debris, submerged objects, and other anomalous features.

- Dual-frequency side-scan sonar system
- Operating frequencies: 400 kHz and 900 kHz
- Used to collect high-resolution acoustic imagery of the bottom
- Used to support identification of debris, submerged objects, and bottom features
- Side-scan sonar contacts were reviewed and exported as part of the survey deliverables

Side-scan sonar data were processed and reviewed to identify visible contacts and anomalous features. Contact locations were compared against the high resolution bathymetric data to see if the multibeam data could support the contacts noticed in the side scan data.

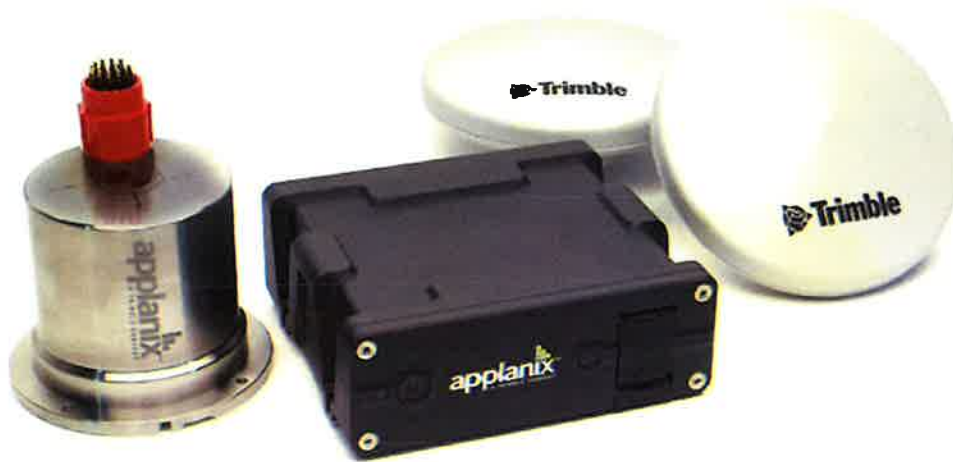
Figure 4-4 – Applanix POSMV WaveMaster V5

- Horizontal position accuracy: approximately 0.03 m real-time RTK/RTX; approximately 0.01 m post-processed
- Vertical position accuracy: approximately 0.06 m real-time RTK/RTX; approximately 0.02 m post-processed
- Roll and pitch accuracy: approximately 0.02° real-time; approximately 0.015° post-processed
- Heading accuracy: approximately 0.03° with a 2-meter GNSS antenna baseline
- TrueHeave accuracy: approximately 5 cm or 5% real-time, whichever is greater; approximately 2 cm or 2% post-processed

Supports post-processed kinematic positioning using POSPac with GPS and GLONASS observations

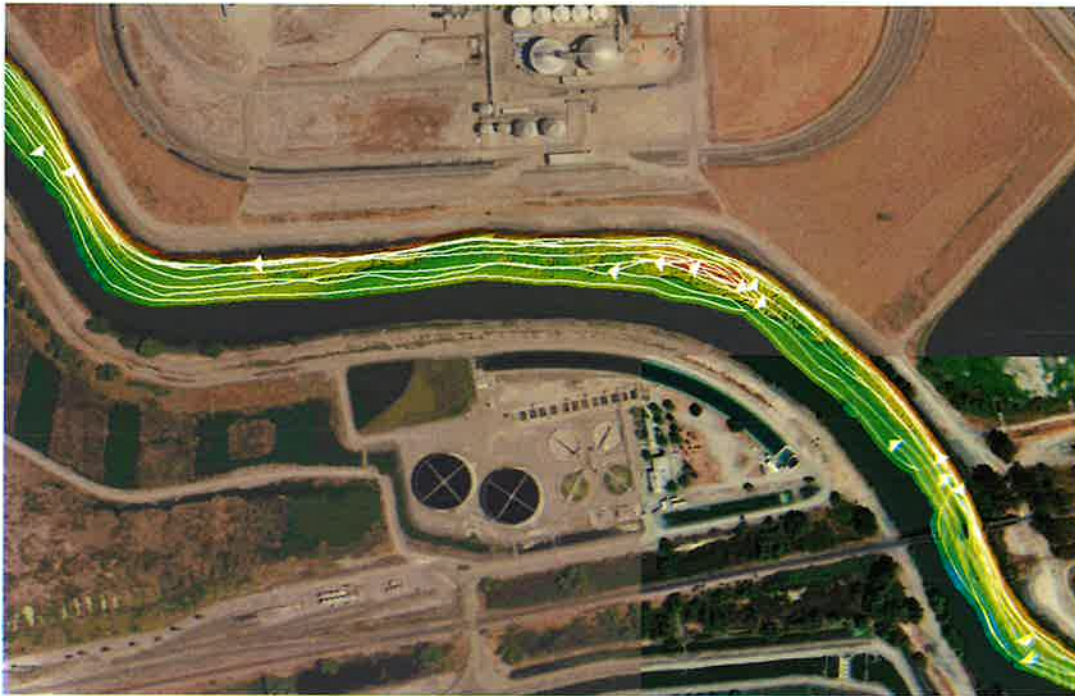
The increased density of survey lines along the eastern bank of the river reflects targeted efforts to obtain the highest-resolution bathymetric data possible within the primary area of interest. The waterside levee slope along the eastern bank was surveyed with additional overlap to maximize data coverage and improve feature detection.

Figure 5-1. Multibeam survey lines shown in white over the bathymetric surface.

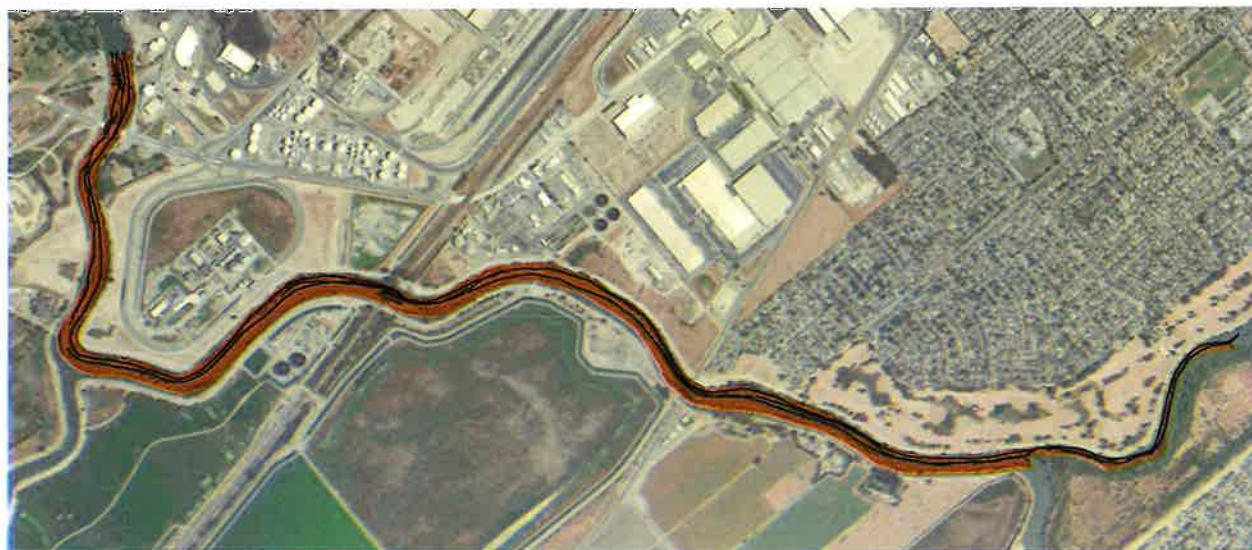
Side-scan sonar data were collected along seventeen (17) survey lines within the area of interest. Data was collected using dual-frequency side-scan sonar, and the high-frequency channel was used for processing, contact review, and figure generation.

**Figure 5-3. Side-scan sonar survey lines shown in black over the side-scan sonar mosaic.**

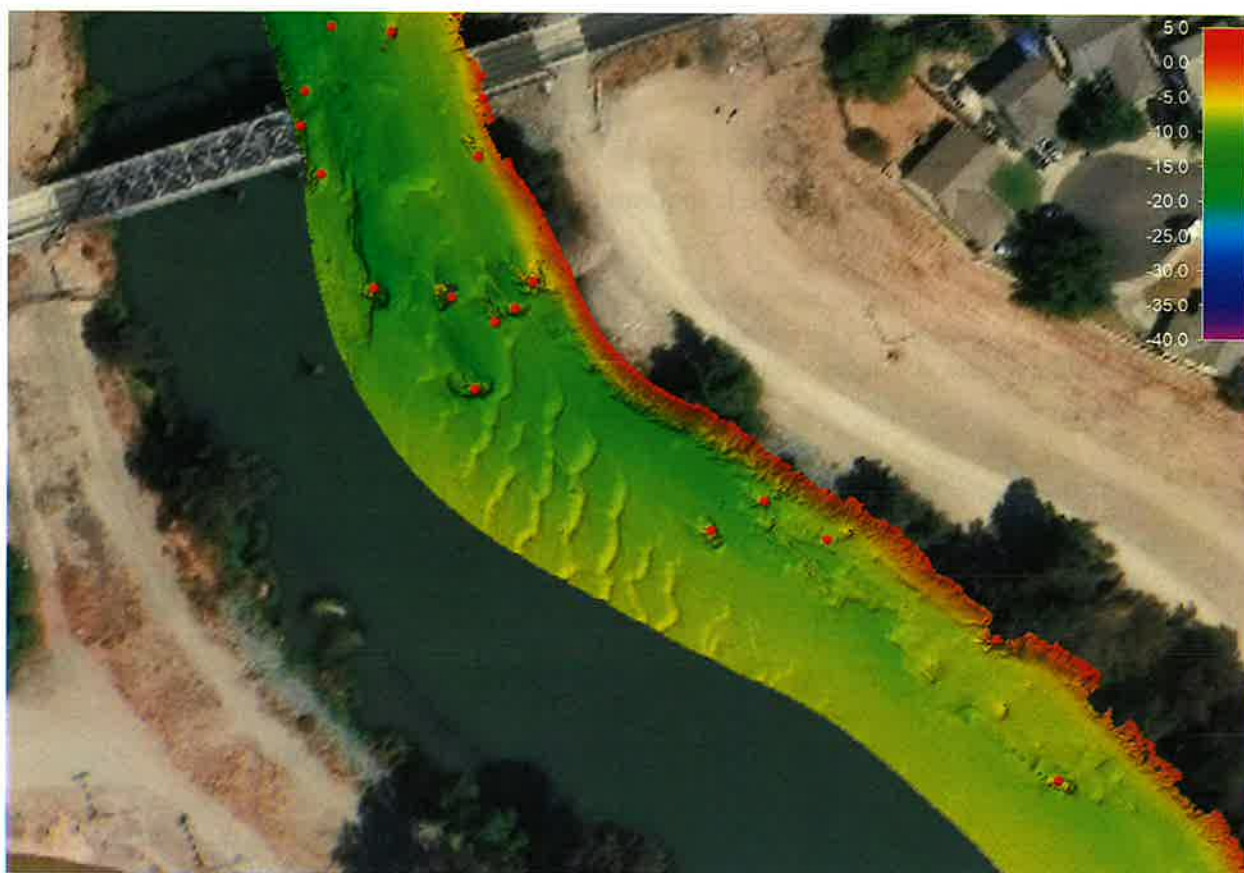
Where applicable, side-scan sonar contacts were compared with the multibeam bathymetric dataset to evaluate surrounding bottom conditions and determine whether the contacts were visible in the bathymetric surface or point cloud. Comparison was not possible for contacts located outside the multibeam survey coverage.

Figure 5-4 – Side-scan sonar contacts overlaid on the multibeam bathymetric surface.
